The effect of bridge failures on UK technical policy and practice

R. J. Bridle FREng, FICE, FRSA and F. A. Sims OBE, FREng, FRSA, FICE

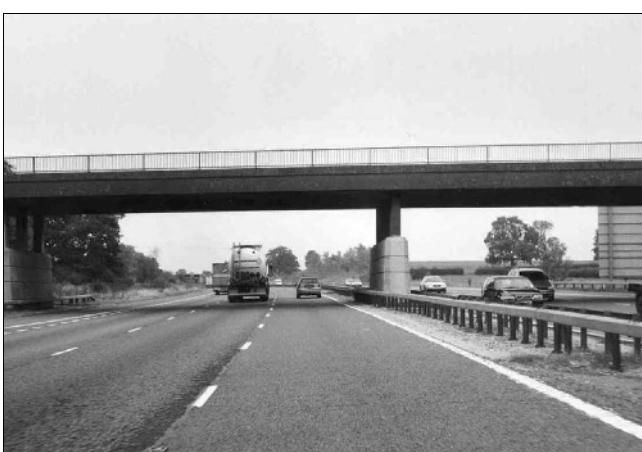
From the introduction of Operation Bridgeguard the assessment of the nation's bridges by the DOT, local highway authorities and other bridge owners, including bridges over railways and waterways, has become a continuing task. Consulting engineers have provided additional input. Bridges found to be weak have had weight restrictions imposed and in some cases with width restrictions to reduce loading until strengthening could be undertaken. Some bridges have been demolished and rebuilt. A large number of bridges have been strengthened or given added protection to meet revised impact criteria (see Figure 1).

Figure 1. Pier strengthening

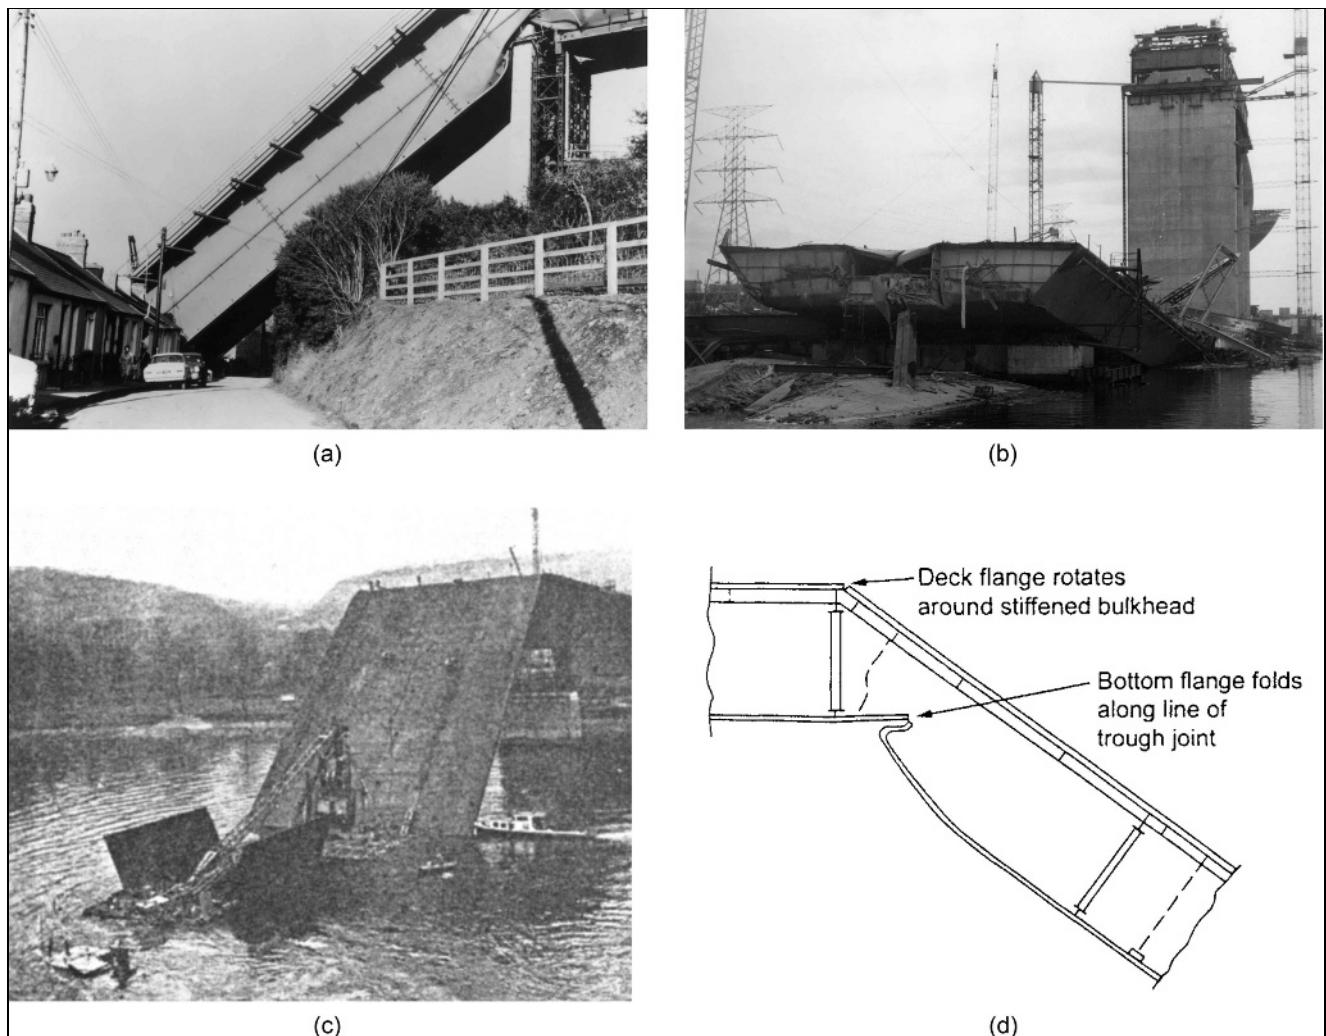
In the case of the Cleddau Bridge, failure occurred through buckling of the diaphragm above the pier as the box-sections were cantilevered out, over the river. Somehow or other the design thickness had become translated from $\frac{3}{4}$ in to $\frac{3}{8}$ in on the manufacturing drawings. How this happened was never established.

The Koblenz Bridge also failed during the cantilevering process. The contractor wished to make the transverse weld between the boxes automatically and, to achieve this, cut back the stiffeners on the bottom plate to allow for the welding process. The missing stiffener sections were replaced but were only welded to

the ends of the existing stiffener and not welded to the bottom plate. Consequently, the unstiffened part of the plate buckled as the cantilever was extended and the load on the plate increased.

The Yarra Bridge was a failure of communication and supervision during erection. The two halves of the box were to be bolted together but buckles, owing to construction, made the task impossible. The resident engineer on the site directed the use of kentledge to press out the buckles, without consultation with the designers and with disastrous consequences.

Figure 2. Failure of box-girder bridges during construction:⁴ (a) Milford Haven; (b) Yarra Bridge; (c) Koblenz Bridge; and (d) mechanism of failure at Koblenz (reproduced courtesy of the Highways Agency, the Institution of Civil Engineers and the consulting engineer. Copyright reserved)

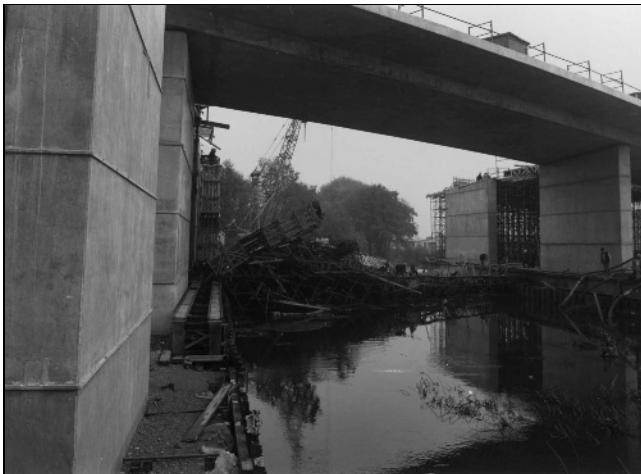
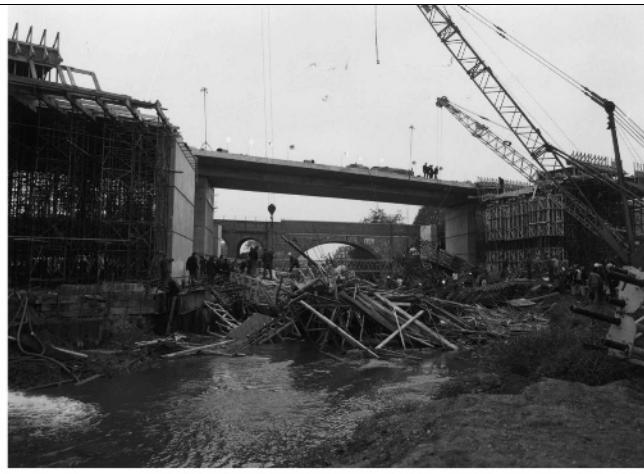
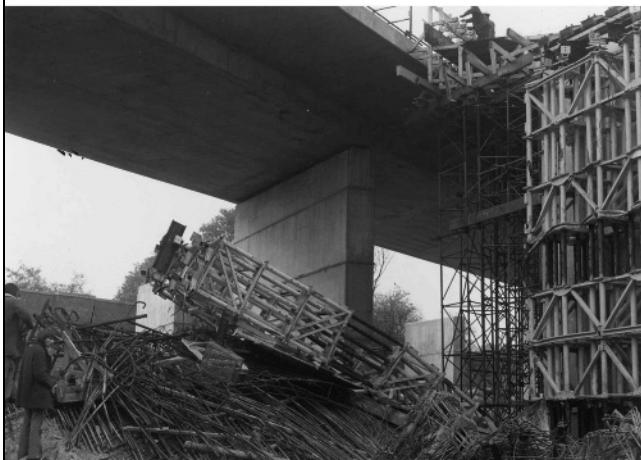
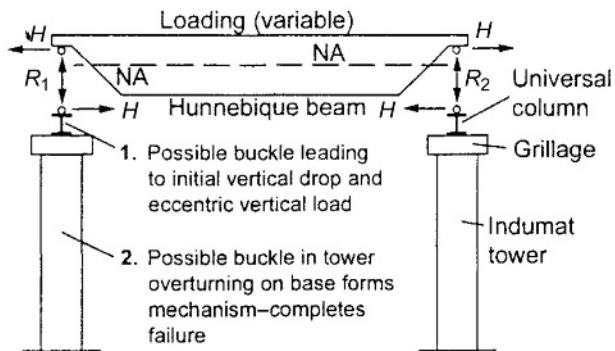
Once again the ramifications led to a new procedure governing the design and erection of temporary works and the oversight of construction processes. The collapse occurred on 24 October 1972⁴ when falsework supporting a span of the A329 dual-carriageway viaduct over the River Lodden, near Reading, failed while a load of concrete was being poured.

The temporary structure consisted of steel trestles resting on horizontal beams on the permanent pier foundations supporting steel trusses. The steel trusses carried the shutting within which the permanent deck would be cast. Both piers and trusses were commercially produced products.

Nothing now remaining on file gives a specific explanation of the failure and that shown in Figure 3 is the speculation of the bridges engineering division. G. Baker, who led the investigation for HM Factory Inspectorate, said that it may never be possible to establish the precise order of events but pointed to the grillage and its immediate supports as triggering successive failure in the structure as a whole.

Figure 3. Collapse during construction of Lodden Bridge.⁴ (a) failure looking upstream; (b) failure looking downstream; (c) the Indumat tower after the failure; (d) speculation on the mechanism of failure (reproduced courtesy of the Highways Agency. Copyright reserved)

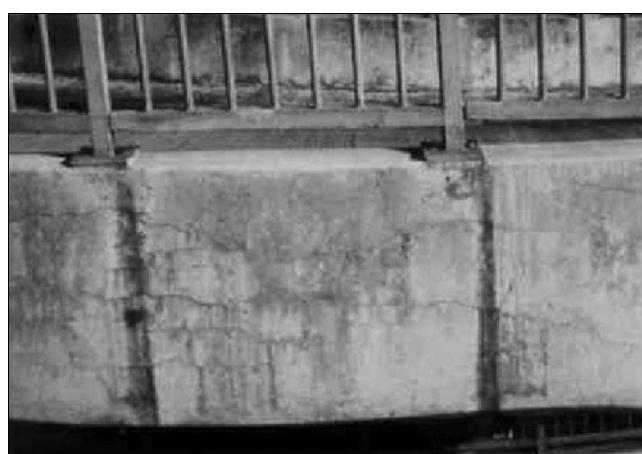
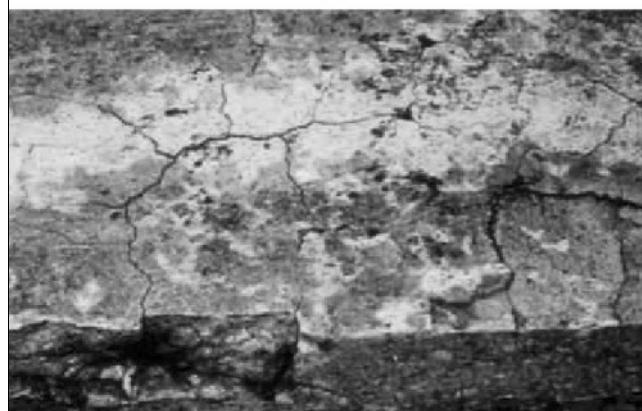
The phenomenon known as ASR was first identified in the USA in the 1940s and was found to occur in concrete when certain siliceous minerals in the aggregate react with alkaline pore solution in the cement matrix. As a result of the reaction expansive forces are generated sufficient to crack the concrete of structural members and reduce their load-carrying capacity (see Figure 4). From 1946 and through the 1950s research work was carried out at the Building Research Station, which led to the mistaken conclusion that the UK was unlikely to be affected. Thus when the early motorways were constructed, ASR had not been classified as a problem, but in the late 1970s an increased number of instances were identified in bridges and other structures.

Figure 4. Evidence of ASR (reproduced courtesy of the Concrete Bridge Development Group.¹¹ Copyright reserved)

For those authorities concerned with maintenance of the bridge stock, DOT technical advice note BA 23/86 was produced covering the investigation and repair of concrete structures affected by ASR. BA 35/90 superseded this in 1990 as more research came to hand.
